## Rehabilitation and Development of Well 3-93 and Well 7-00

Clearbrook Waterworks District

GW Solutions Inc.

August 2008

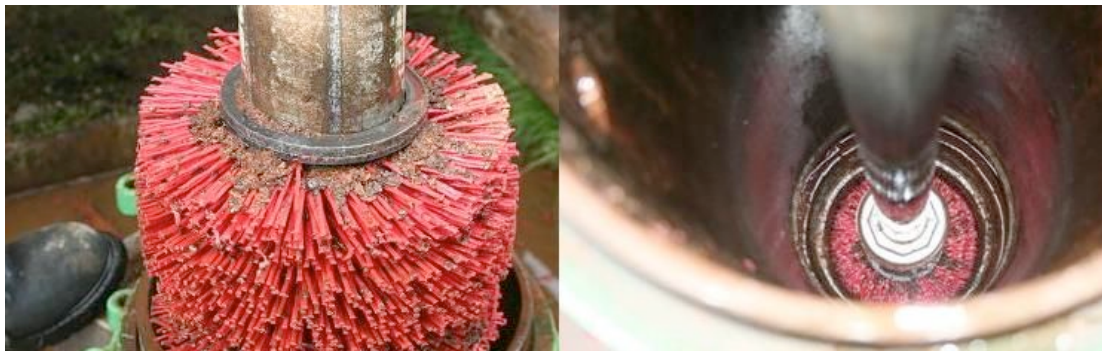
**Figure 1: Brushing of Well 3-93**

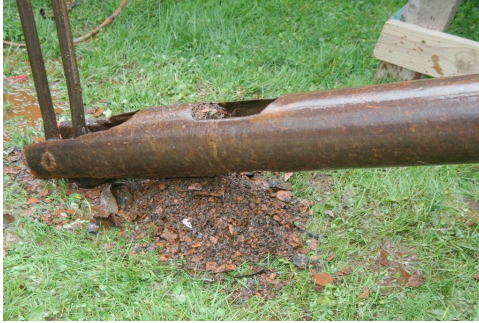
**Figure 2: Bailer used for removing debris from the wells.**

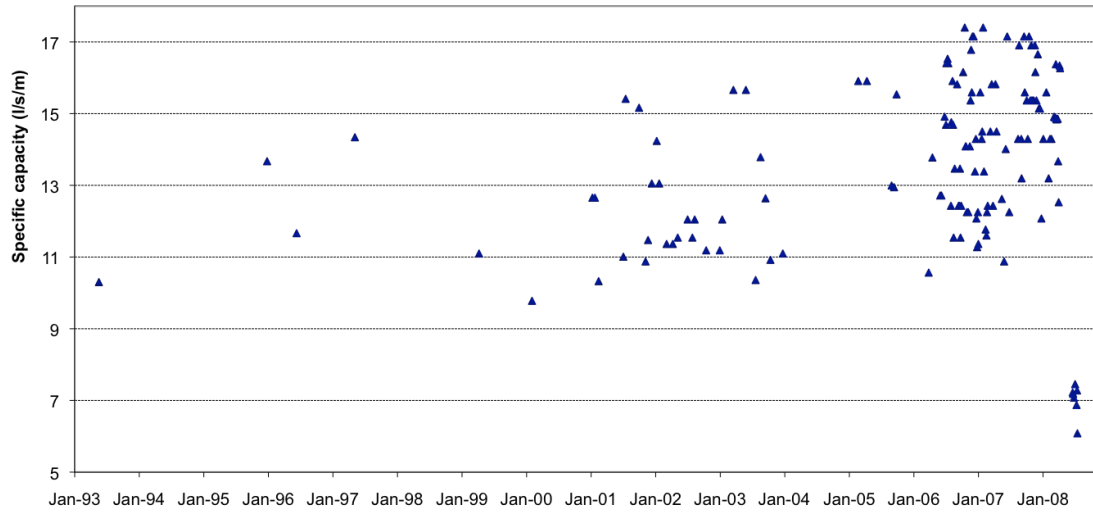
Well 3-93 - Specific Capacity

Figure 3: Specific capacity vs time - Well 3-93

Figure 3 shows that the initial specific capacity of Well 3-93 was reported to be 10.3 l/s/m immediately after construction of the well in 1993. Based on data recorded (pumping rates, depth to water at rest and when pumping), the specific capacity has ranged between 11 l/s/m and 17 l/s/m. After development, the specific capacity is calculated to range between 6 l/s/m and 7 l/s/m. We therefore observe a reduction in specific capacity when comparing the post-development values to the pre-development values.

No trends in the variation of the specific capacity are identified for well 3-93 because the data appear as a cloud in Figure 3. However, for Well 7-00 (figure 4), there is an observed reduction in specific capacity versus time between 2004 and 2007. It also clearly shows two sets of data, one between 10 l/s/m and 12 l/s/m and the other between 13 l/s/m and 14 l/s/m. This corresponds to a difference in efficiency when Well 7-00 pumps at the same time as Well 3-93 or when it is the only producing well. When pumping with Well 3-93, the discharge rate is lower and the drawdown is greater, resulting in a lower specific capacity.

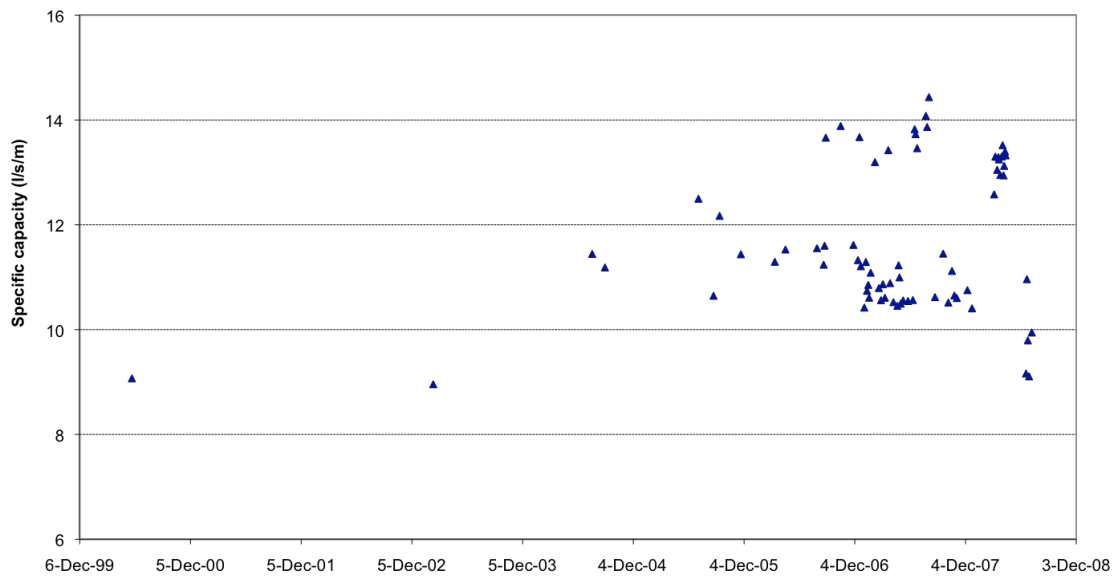
Well 7-00 - Specific Capacity

Figure 4: Specific capacity vs time - Well 7-00

Figure 4 shows that the initial specific capacity of Well 7-00 was reported to be 9.1 l/s/m immediately after construction of the well in 2000. Based on data recorded (pumping rates, depth to water at rest and when pumping), the specific capacity has ranged between 10 l/s/m and 14 l/s/m. After development, the specific capacity is calculated to range between 9 l/s/m and 11 l/s/m.

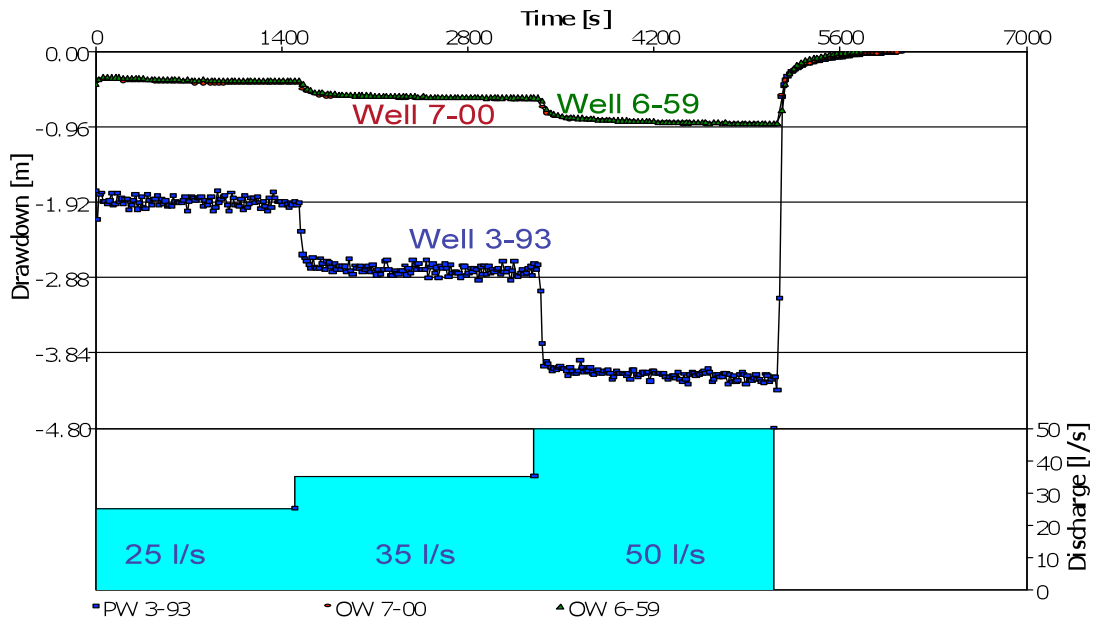
Pre Rehabilitation Step Test (April 14, 2008) Well 3-93

Figures 5 through 7 and Table 1 summarize the results of the step tests, performed before (Wells 3-93 and 7-00) and after rehabilitation (Well 7-00). Figure 5 illustrates how pumping in Well 3-93 causes drawdown in Wells 7-00 and 6-59. Drawdown in Well 3-93 ranges between 1.92 m and 4.16 m (based on data logger information). Drawdown ranges between 0.37 m – 0.88 m and 0.41 m – 0.92 m for Wells 6-59 and 7-00, respectively. A drawdown of about 9 cm was observed in Well 1-87.

Figure 5: Pre-rehabilitation step test - Well 3-93

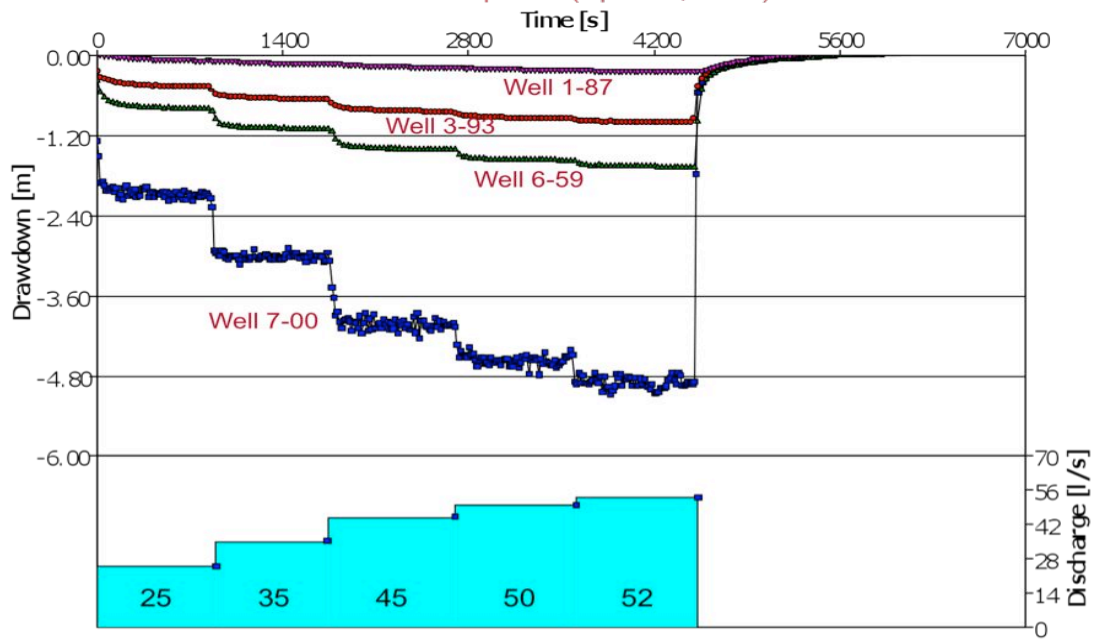
Pre Rehabilitation Step Test (April 21, 2008) Well 7-00

Figure 6 shows the increase of drawdown in Well 7-00 with the increase of pumping rates. In a similar way, drawdowns were recorded in wells 1-87, 3-93 and 6-59. Figure 7 shows the observed drawdowns in Well 7-00, after rehabilitation and the difference compared to the observed drawdowns in well 7-00 before rehabilitation, as indicated by the double arrows. The difference is in the order of 1 m.

Figure 6: Pre-rehabilitation step test - Well 7-00

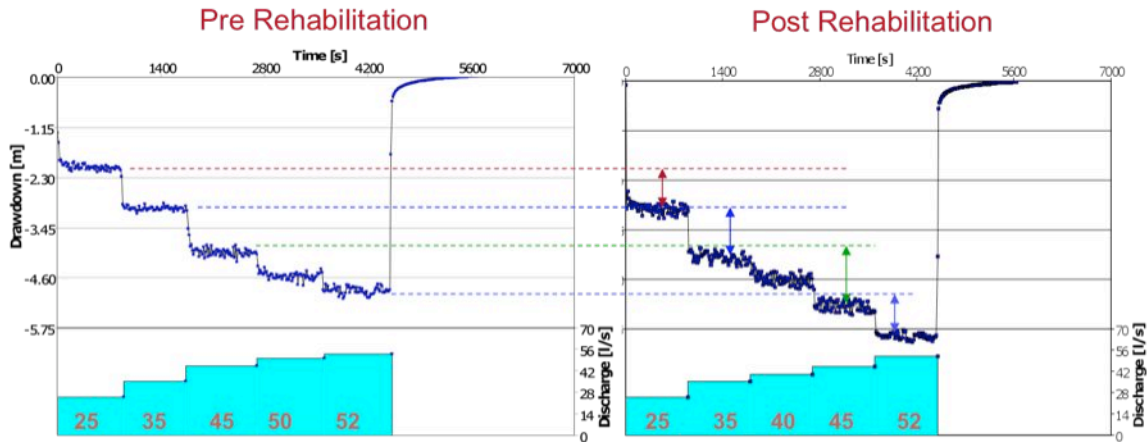
Post Rehabilitation Step Test (April 26, 2008) Well 7-00

Figure 7: Comparison pre and post-rehabilitation drawdowns - Well 7-00
